## Synthesis Of Art Deco and Sundanese Script Visual Identities in Asia Afrika Signage

Signage,  
Experiential  
Graphic Design,  
ArtDeco,  
Sundanese Script,  
Heritage Area

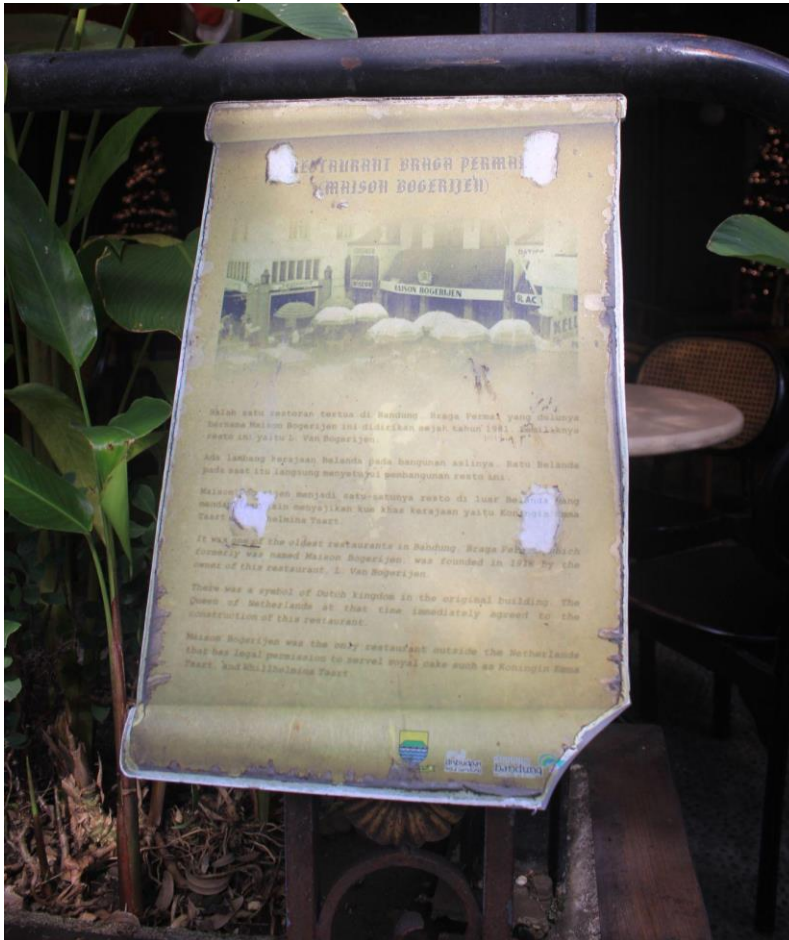
information boards installed on heritage buildings, such as Maison Bogerijen, show severe material deterioration that significantly reduces legibility. This condition limits the effectiveness of historical information delivery to visitors. The observed deterioration is documented in Figure 1.

Figure 1. Physical condition of historical information signage showing material degradation and reduced legibility.

The historical information boards provide the clearest evidence of a legibility problem. Peeling surfaces and faded color reduce figure-ground contrast, while relatively small text creates a dense information field that is difficult to access from a normal pedestrian position. In this case, material degradation is not merely a maintenance issue; it directly interferes with the informational function of the sign. The same evidence also shows that legibility depends on the relationship between physical condition, typographic scale, contrast, and viewing context rather than on typography alone. Figure 1 shows the deterioration discussed in this assessment.

From the perspective of legibility, the deteriorated historical information board demonstrates how material condition and graphic organization jointly affect access to information. Gibson (2009) emphasizes the importance of rapid recognition in wayfinding, while the present evidence shows that recognition can be compromised before content is interpreted, because fading, small text, and dense composition reduce visual accessibility. Consequently, maintenance standards should be treated as part of communication design rather than as a separate technical issue.

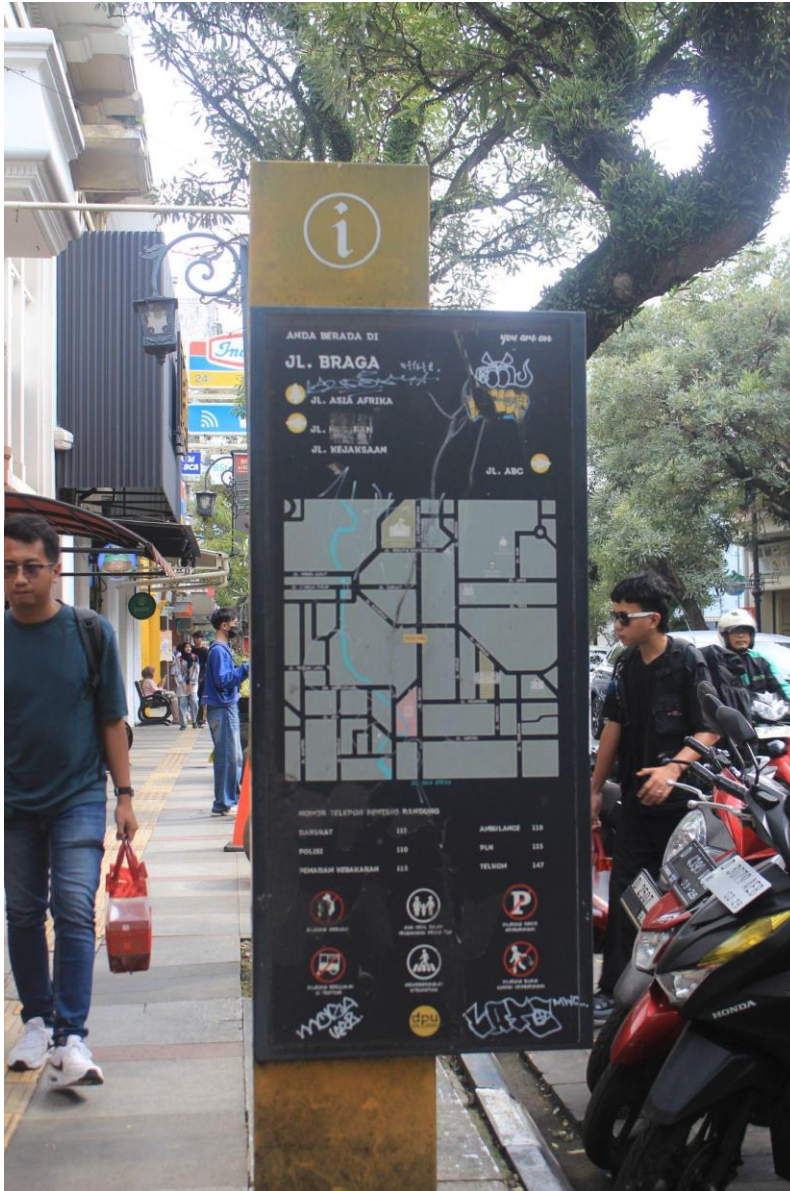
In addition to physical problems, inconsistencies are also found in the application of visual identity. As illustrated by the orientation map in Figure 2, the existing wayfinding uses a modern-generic visual style that is disconnected from the surrounding Art Deco architectural context. In contrast, the Art Deco style (Solikhah, 2024), which was popular during the 1920s and 1930s, is characterized by strong geometric forms, bold lines, symmetrical compositions, and elegant sans-serif letterforms. These visual characteristics have the potential to be adopted into environmental graphic elements to strengthen the visual identity of the area. Art Deco elements also appear in contemporary Bandung interiors; Febrian and Widia (2025), for example, documented geometric and ornamental applications in the lobby of *él Hotel Royale Bandung*. This interior-design example provides local stylistic context rather than direct evidence about signage performance.

Figure 2. Existing orientation map design with a modern-generic style that does not reflect the historical character of the area.

The orientation map, identification signs, and other vertical signage do not display a stable visual grammar. The orientation map (Figure 2) uses a modern-minimalist treatment dominated by black and yellow, while the street-name sign (Figure 3) employs a different decorative form and includes Sundanese script. The vertical “Smoking Area” sign (Figure 4) introduces another visual language through its elongated format and high-contrast red field. When these elements are read as parts of one environmental graphic system, their typography, color, form, and compositional logic appear unrelated. The issue is therefore not that every sign must look identical, but that the documented signs do not demonstrate sufficient visual continuity to be perceived as parts of a coordinated heritage signage system.

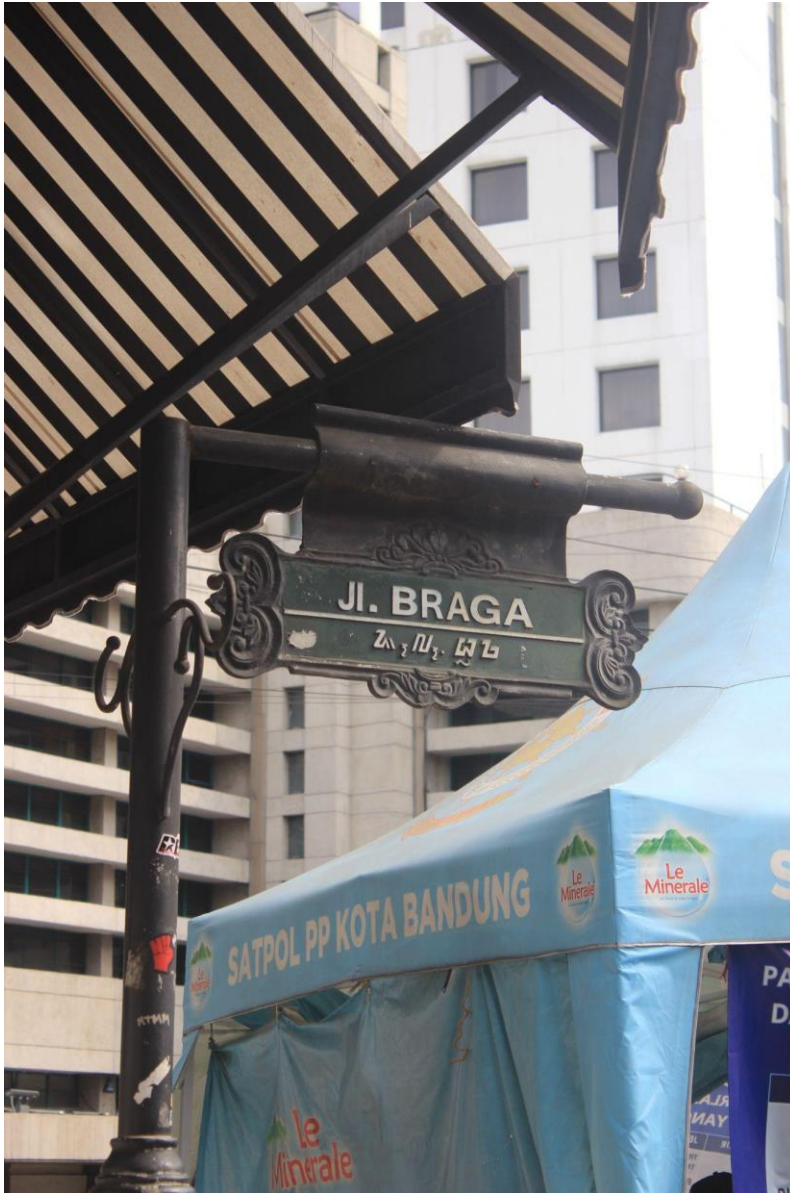
Furthermore, the application of Sundanese script as a representation of local identity has not been optimal. West Java Regional Regulation No. 5 of 2003, as amended by Regional Regulation No. 14 of 2014, provides a legal framework for the preservation of regional languages, literature, and scripts (Pemerintah Provinsi Jawa Barat, 2014). However, its implementation in signage within the Asia Afrika area remains subordinate and inconsistent; it appears only on street name signs but is absent from other informational media. In the context of Experiential Graphic Design, vernacular or local typography can strengthen regional identity (*local genius*) in public spaces. The street-name sign with Sundanese script is shown in Figure 3.

Figure 3. Application of Sundanese script on street name signage, but not consistently implemented on other signage elements.

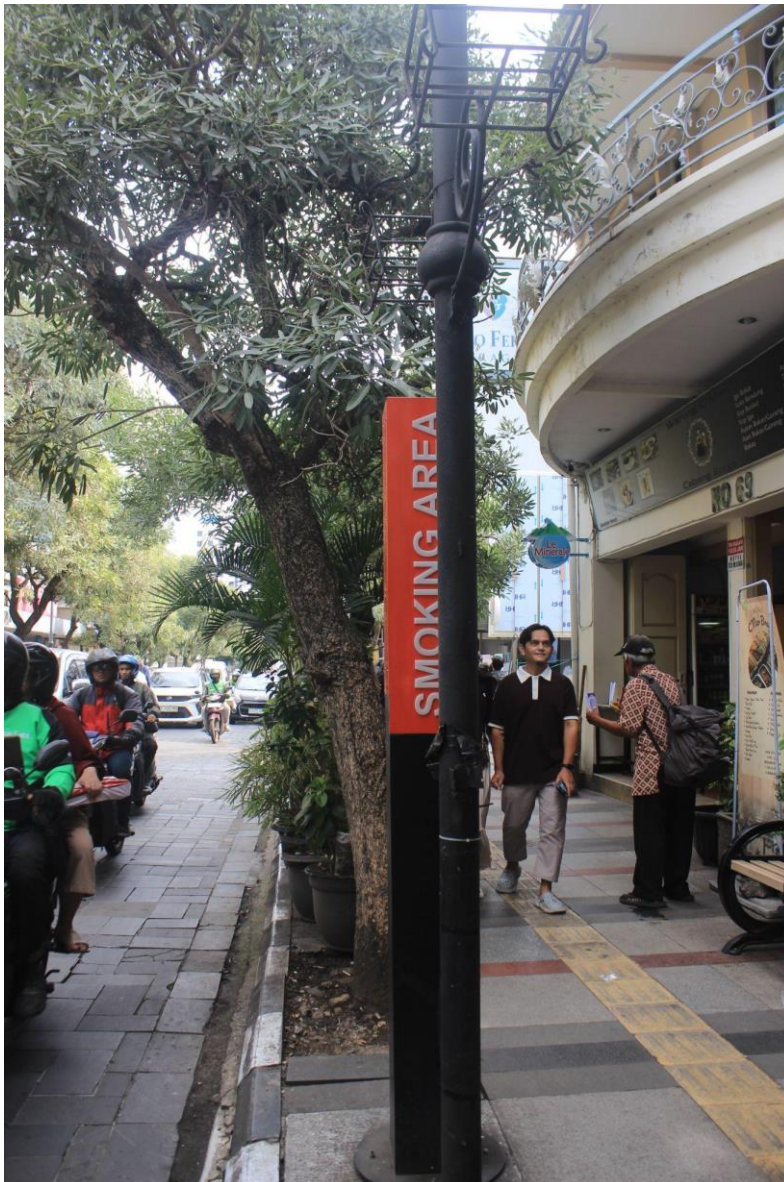
Figure 4. Vertical signage placement that is visually inconsistent with the surrounding classical architectural elements.

information environment (Calori & Vanden-Eynden, 2015). The contrasting examples in Figures 2–4 therefore indicate a gap between the presence of individual signs and the formation of a coherent signage identity. This gap explains why replacing individual signs without a shared design logic would be insufficient.
